Resource Condition Report for Significant Western Australian Wetland

Vasse Estuary

2008

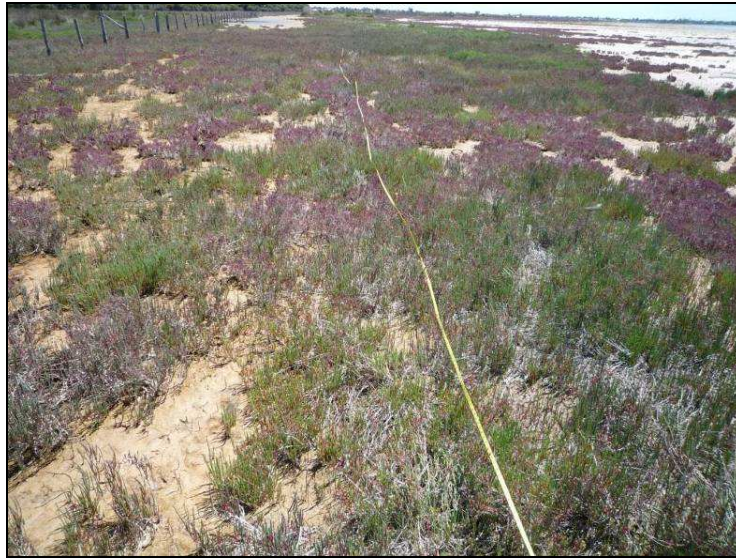
Figure 3 – Vasse Estuary vegetation transect RCM043-R1.

Transect RCM043-R1 was established approximately 15 m from the water's edge. The black, muddy substrate was completely waterlogged at the time of survey. Vegetation was comprised of a single stratum dominated by *Sarcocornia quinqueflora* and *Tecticornia pergranulata* low samphire shrubland with scattered grasses and herbs including *Paspalum vaginatum*, *Triglochin mucronata* and *Cotula coronopifolia* (56.6% cover, <0.4 m tall). Table 3 provides a complete list of taxa recorded on transect RCM043-R1.

There was an abundance of recently germinated samphire seedlings along the transect (Figure 3). Two of the species recorded on the transect were weeds (*P. vaginatum*, *C. coronopifolia*). The overall community condition was considered 'natural' (Table 8 in Appendix 1).

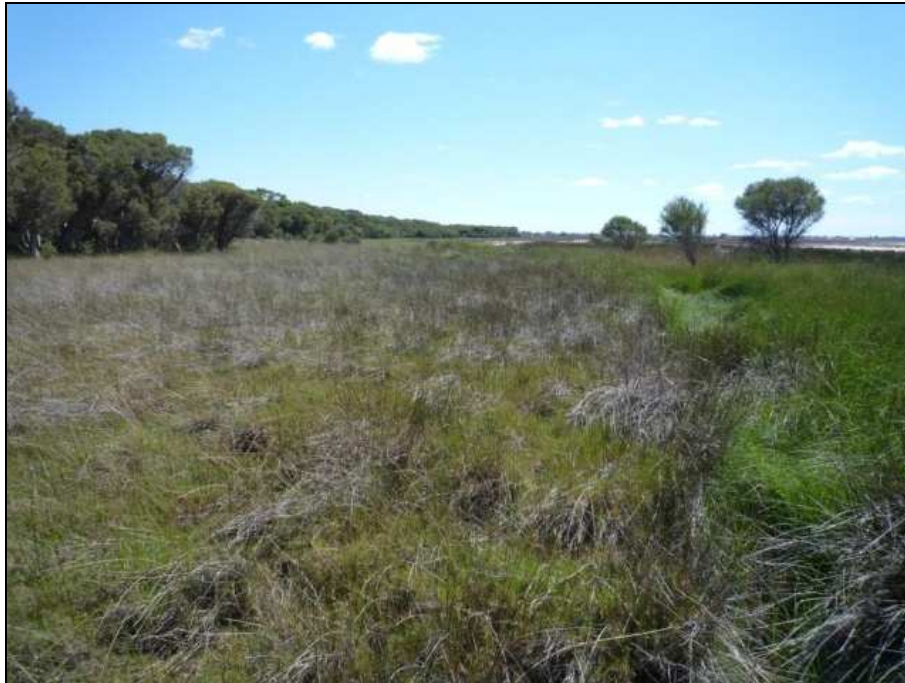
Figure 4 – Vasse Estuary vegetation transect RCM043-R2.

Transect RCM004-R2 was established approximately 30 m from the water's edge. The substrate was completely waterlogged at the time of survey. The vegetation was comprised of a single stratum of *Juncus kraussii* subsp. *australiensis*, *Carex divisa*, *Paspalum vaginatum* mid-high closed rushes/sedges/grasses (100% cover, <1 m tall) (Figure 4). Table 4 provides a complete list of taxa recorded along the transect RCM043-R2.

Two of the four species recorded on the transect were weeds (*C. divisa* and *P. vaginatum*), totalling approximately 50% of the vegetative cover. The overall community condition was considered 'impacted' (Table 8 in Appendix 1).

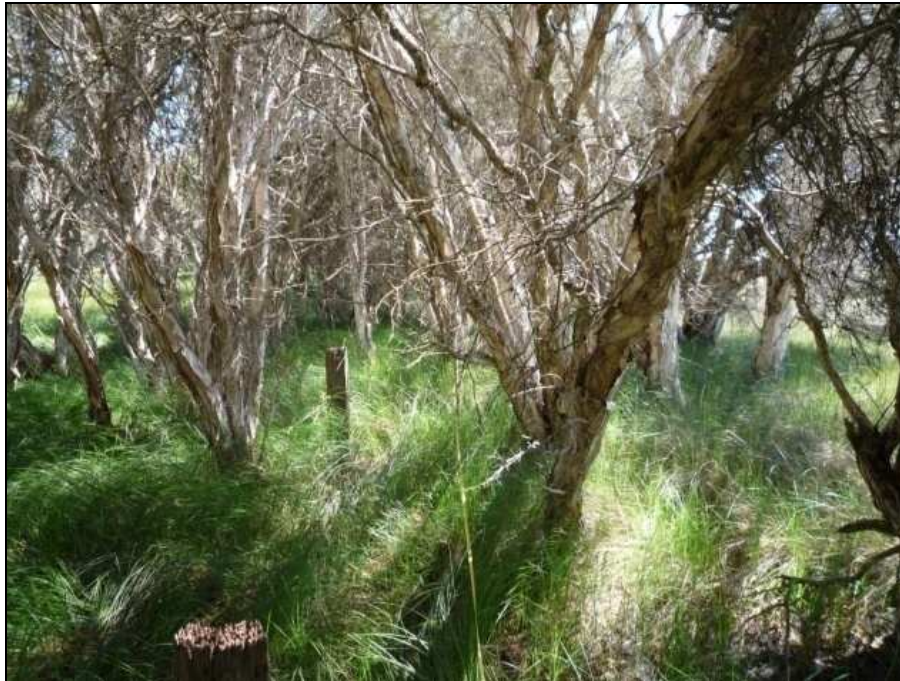
Figure 5 – Vasse Estuary vegetation transect RCM043-R3.

Transect RCM043-R3 was established approximately 50 m from the water's edge. The soil was peaty, with a high organic content, and waterlogged at the time of survey. Vegetation was dominated by *Melaleuca cuticularis*, *M. viminea* subsp. *viminea* low closed forest (100% cover, <8 m tall) over *Carex divisa*, *Juncus kraussii* subsp. *australiensis* mid-high sedges and rushes (60% cover, <0.8 m tall). Table 5 provides a complete list of taxa recorded along the transect RCM043-R3.

Three species of weed were recorded on the transect contributing to the majority of vegetative cover in the understorey (Figure 5). The overall community condition was considered 'impacted' (Table 8 in Appendix 1).

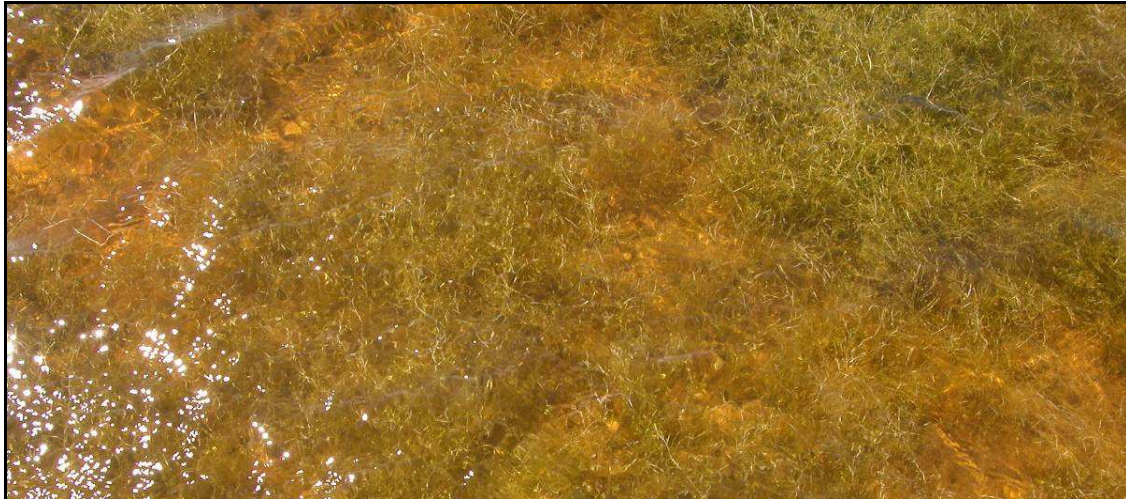
Figure 6 – Aquatic vegetation of Vasse Estuary.

No benthic vegetation was recorded from the area sampled, as the water had receded a large distance from the littoral vegetation. However, the inundated areas of Vasse Estuary were densely covered with *Ruppia sp.* (Figure 6).

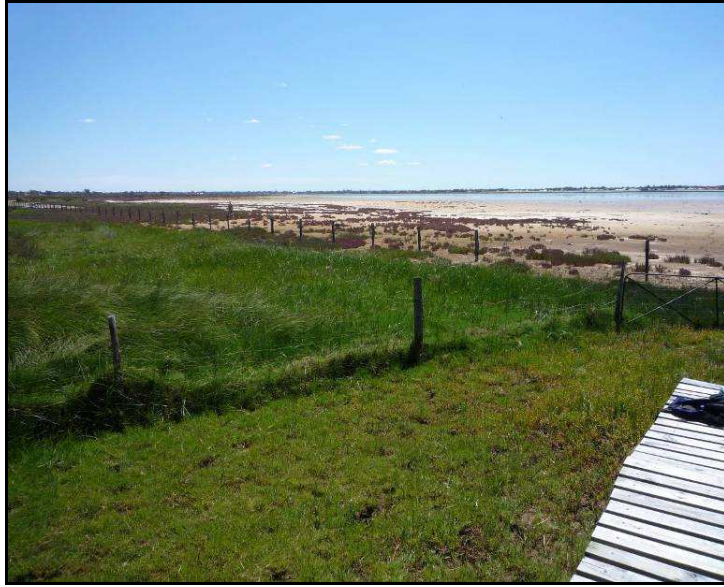
Not surprisingly, considering the Vasse Estuary's close proximity to grassed paddocks and residential gardens, weeds were present at the site (Figure 7). An estimated five percent of the site was impacted by weeds. Pasture grasses (Kikuyu & Couch) have been identified as impacting the Vasse-Wonnerup Wetland System, as well as Bridal Creeper, Arum Lilies and *Typha* (Wetland Research & Management 2007).

Figure 7 – The change from exotic, urban influenced vegetation to the samphire dominated riparian vegetation to the south of Vasse Estuary.
